### **3.0 FIELD TESTS**

This section describes the field tests undertaken to test the use of videotape in HOV lane surveillance and enforcement. Each test is described, findings from the field demonstrations and subsequent analyses are documented, and results are summarized.

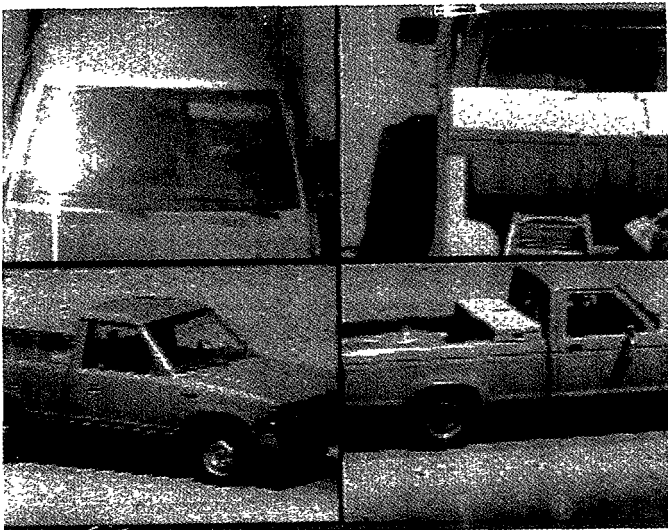
**(C) FOUR-CAMERA DISPLAY**

1. Front View of Oncoming Vehicle
2. Oblique View of Oncoming Vehicle
3. Rear View of Departing Vehicle
4. Side View of Departing Vehicle

| 3. Single camera, rear view | 10. Four camera (Display C in Attachment B) |

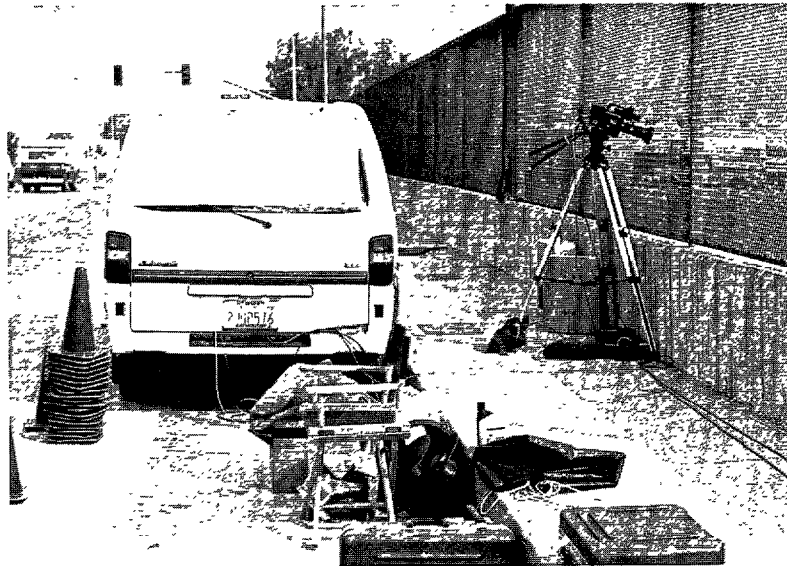
**VAN AND REAR-VIEW CAMERA**

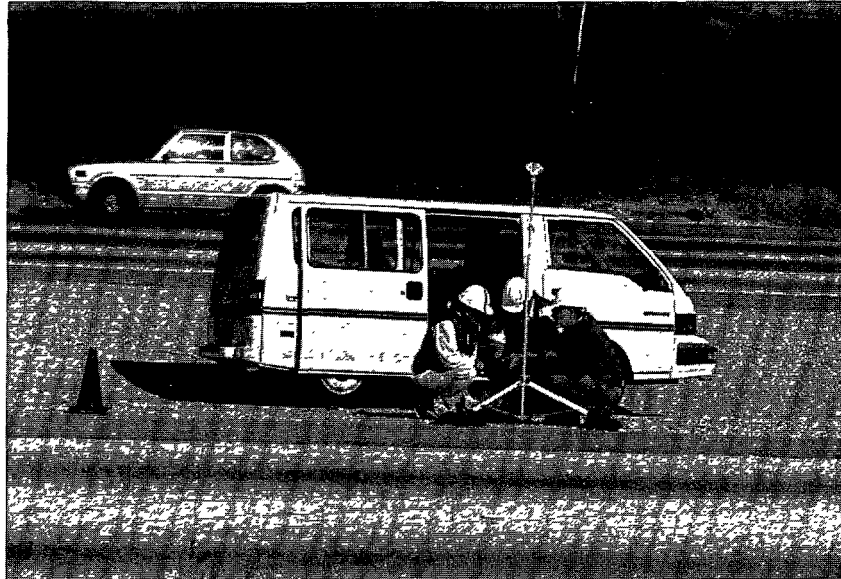
**B-1 Testing Eye-Level Microcamera on Simi Valley Freeway**

- (1) On December 12, 1989, ATD tested the installation of a micro-camera along the Simi Valley freeway at the Winnetka overcrossing. Various camera levels were tested, and best results were obtained from a camera position slightly higher than the car roof, angled downward to provide a view of the passenger seat and right rear seat. Exhibit 3.6-A shows the camera-tripod arrangement tested on the Simi Valley Freeway.

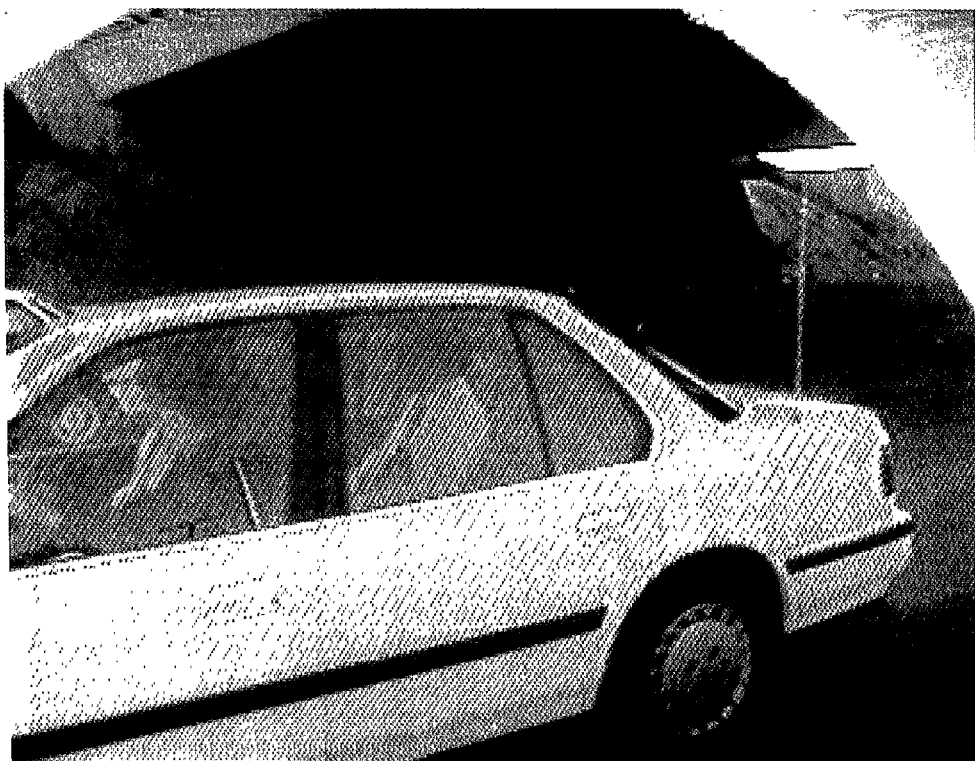
**EXHIBIT 3.8**  
**SAMPLE VIEW FROM EYE-LEVEL CAMERA**

**On-Line Accuracy.** The officer viewing the monitor in the van tended to rely on a single camera view, the view of oncoming traffic provided by Camera #1, in determining whether or not a vehicle was a violator. He rarely experimented with the monitor controls to get the

benefits of the eye-level camera. This may have been because the motor officers observing traffic were located in an enforcement area only 1500 feet downstream from the overcrossing, so that decisions had to be made rapidly. During the period between 4:00 p.m. and 4:30, the officer in the control van radioed the descriptions of 24 suspected violators to the motor officers downstream. Eight of these 24 suspects were found to have the required number of passengers, eight were identified as violators, and eight were not located.\* Of the sixteen suspects verified by close-up observation, therefore, only 50% turned out to be actual violators. This high false-alarm rate can't be taken as a comment on the accuracy of the eye-level camera, however, since in most cases the van officer did not wait to consult the eye-level camera before radioing suspect descriptions.

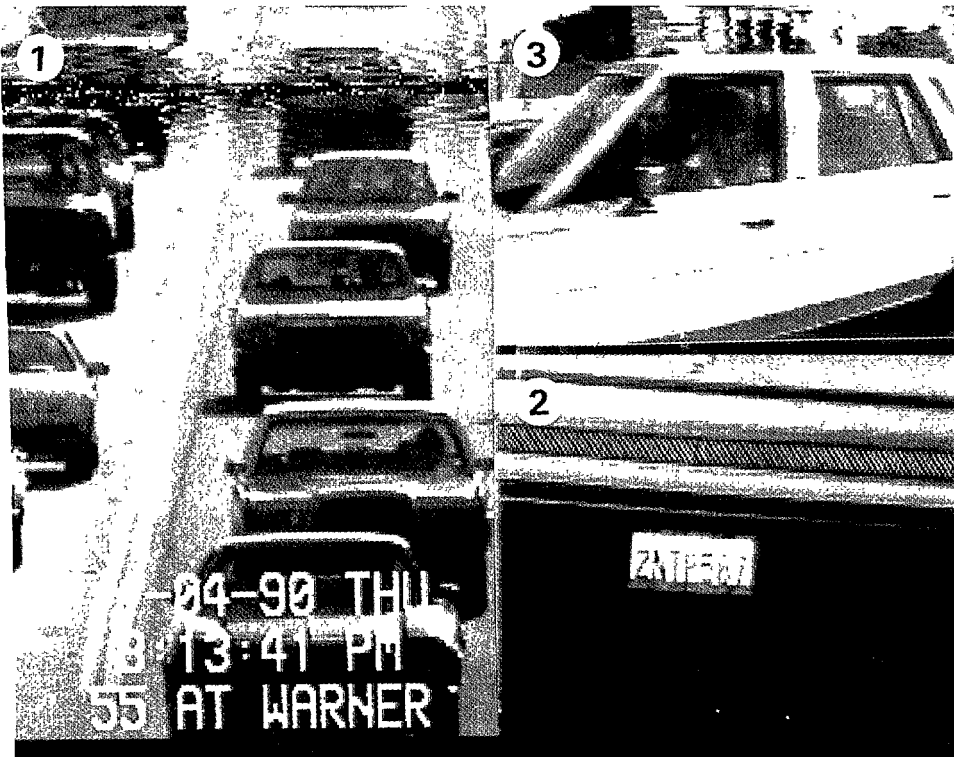
EXHIBIT 3.9  
FINAL SET-UP

1. Oncoming View
2. License View from Bridge
3. Driver's Eye Level View
4. License View from Roadway

**Cameras.** Exhibit 3.9 shows the locations of the four cameras used in the demonstration. The cameras were installed and ready for use at 2:00 p.m. Between 2:00 p.m. and 4:00 p.m. three camera views were fed to the monitor: The oncoming scene recorded by Camera 1 of Exhibit 3.9, license plate data revealed by Camera 2, and an eye level view of passing

traffic provided by Camera 3. At four o'clock, Camera 4 was switched into the system to provide a freeway-level record of license plate information, replacing that of Camera 2. The views of Cameras 3 and 4 were synchronized to provide a simultaneous image of a car's interior and its license plate.

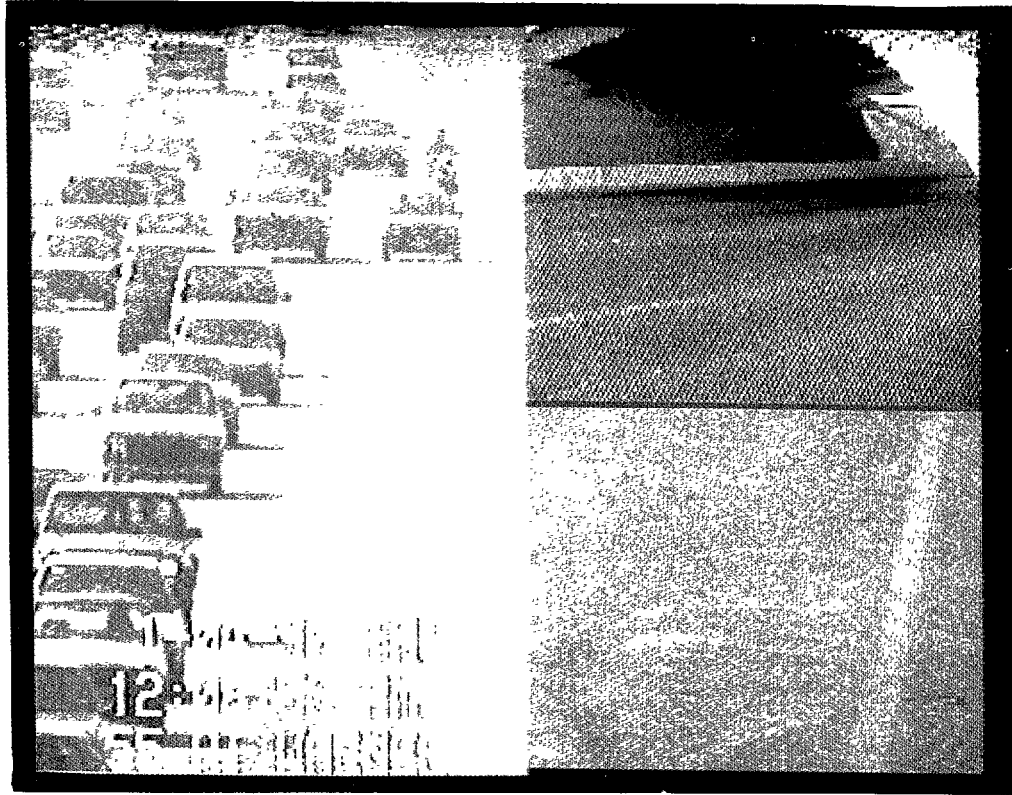
EXHIBIT 3.11  
MONITOR VIEW OF BUFFER VIOLATOR

**Unambiguous Violator Identification: Buffer Violations.** Although many suspected occupancy violations identified on videotape turned out to be false alarms, one type of violator could be unambiguously identified one hundred percent of the time. This was the buffer violator who entered the HOV lane illegally by crossing the double yellow line at a place where lane changing was not allowed. Exhibit 3.11 shows an example of one such violator.

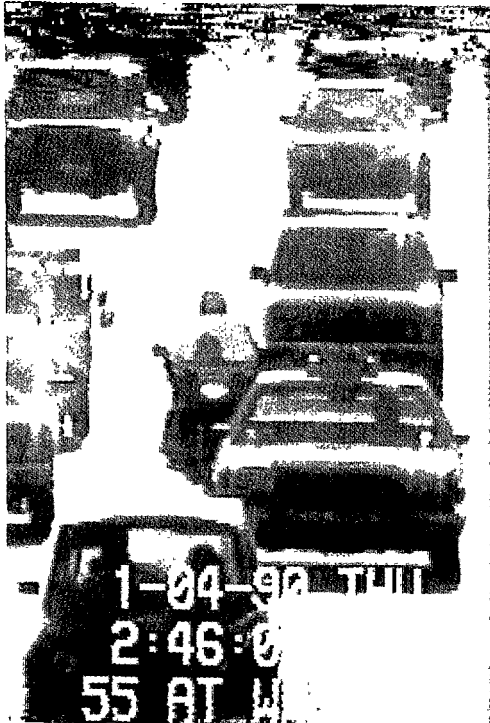
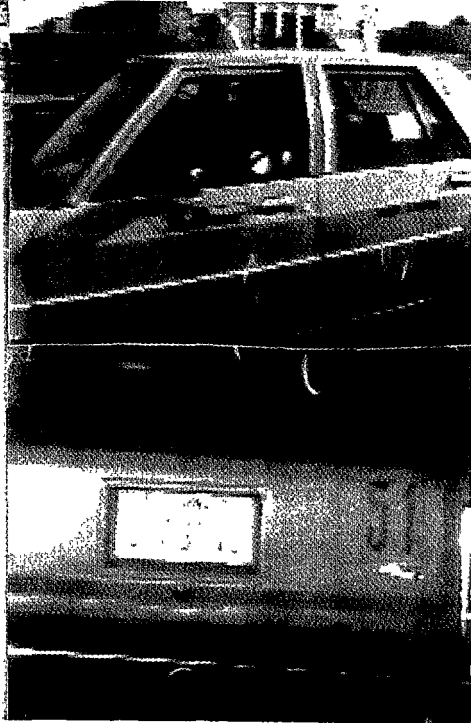
**EXHIBIT 3.12**

**MONITOR VIEWS OF SUSPECTED VIOLATOR  
WITH UNDETECTED CHILD**

**(Yellow Cab #51)**

**ONCOMING VIEW**

**SIDE VIEW**

**Accuracy and ambiguity: Missing Children.** Infants or children hidden from the camera's view were the most common causes of violator misidentification by videotape viewers. Exhibit 3.12 shows three views of a taxi cab videotaped in the OR 55 HOV lane on January 4. The

observer in the control van, along with four subsequent videotape viewers, independently identified the taxi as an HOV lane violator. However, the motor officer observing traffic in the lane downstream from the taping point reported that there was a small child in the cab's back seat. Yet four different observers failed to identify the child in repeated viewings and reviewings of the videotape.

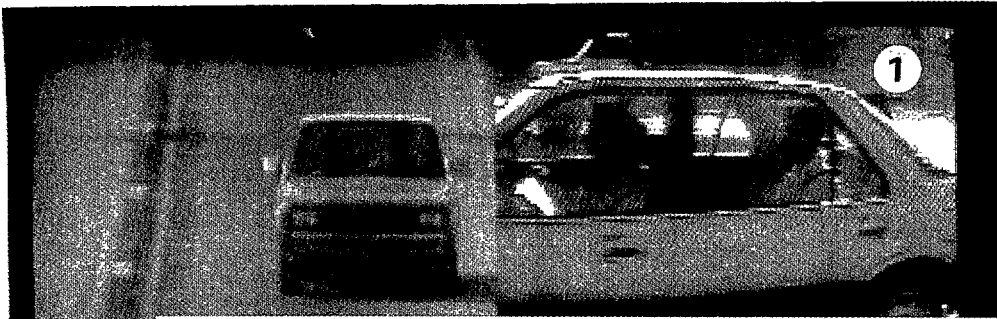
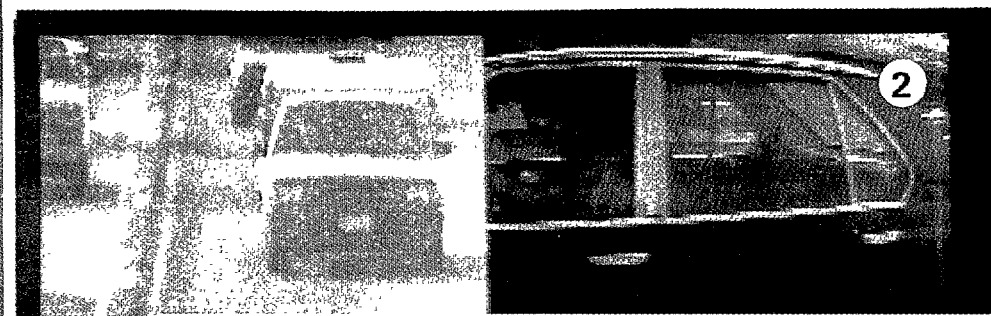
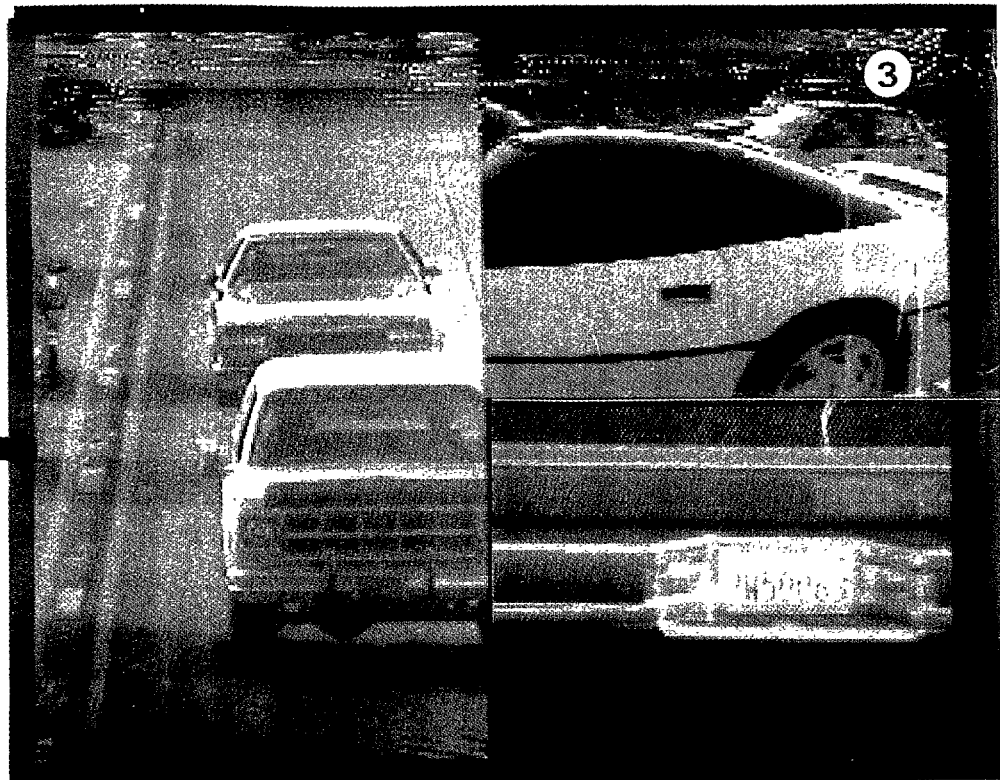
**EXHIBIT 3.13**  
**VIEWS FROM EYE-LEVEL CAMERA SHOWING**

- 1 - Rear Seat Occupant**
- 2 - Empty Rear Seat**
- 3 - Tinted Windows**

**Accuracy and Ambiguity: Tinted Windows.** Exhibit 3.13 shows three views from the eye level camera. In the first view, the rear seat contains a passenger, the second vehicle is a violator (verified by the roadside observer), and the third vehicle has tinted windows, making a judgment on the occupancy of the rear seat impossible. Such problems as tinted windows, sight-obscuring headrests, windshield posts, and ill-positioned vehicles generally caused the videotape viewers to list the occupancy as unknown or guess at the occupancy from a single front view. Most test viewers were reluctant to identify vehicles as potential violators when one or more of the supporting views was obviously obscured. While tinted windows can produce indeterminant or biased occupancy counts, therefore, they are not likely to trigger false violation alarms, so long as the videotape viewers are well trained.

Certain vision-obscuring problems could potentially bias occupancy counts. The vehicles most likely to have windows out of range of the eye-level camera were buses and vans, precisely those vehicles which are likely to carry a high number of occupants. If videotape viewers ignore these vehicles because they can't see into the rear windows, occupancy rates will be artificially low. As noted, moreover, ambiguous views can cause different viewers to react in different ways. Faced with a large number of obscure views from the eye-level camera, one viewer understated violation rates because she shouldn't be sure there wasn't a second occupant somewhere in the car. Another viewer understated the number of vehicles with three or more occupants because he couldn't be sure the back seat was occupied.
